## BEST PRACTICE

LOCATION: Quarry  
ACTIVITY: Power tools and battery safety  
SUB ACTIVITY: No Sub Activity Available  
BEST PRACTICE No: BP2188  
COUNTRY OF ORIGIN:

Lithium battery – Recharger cabinet

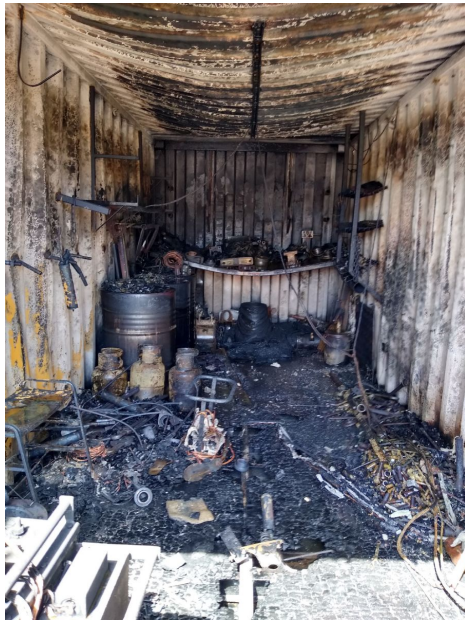
An incident occurred at one of our quarries involving a battery powered impact gun. One of the operators put the battery onto charge in the tool store, which was located in a steel container. Two hours later it was recognised that smoke and visible flames were coming from tool store, the emergency services were called, and the power isolated. The photograph demonstrates the exact nature of the damage created.

- The incident occurred at the charging point for the impact gun charger / lithium-ion battery.
- The impact gun is powered by an 18-volt lithium battery that is charged within a stand-alone 240v charger unit.
- Plant operator put the battery onto charge in the tool store in an 20ft steel container, no defects with the charger or battery were noticed on the pre-charge inspection.

It was situated on a metal shelf and the charger was plugged into 240v internal fitted 3 pin socket which was used on a regular basis with no issues or faults reported.

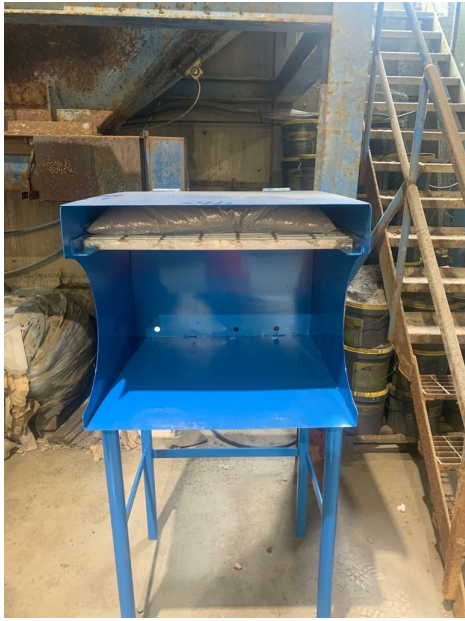
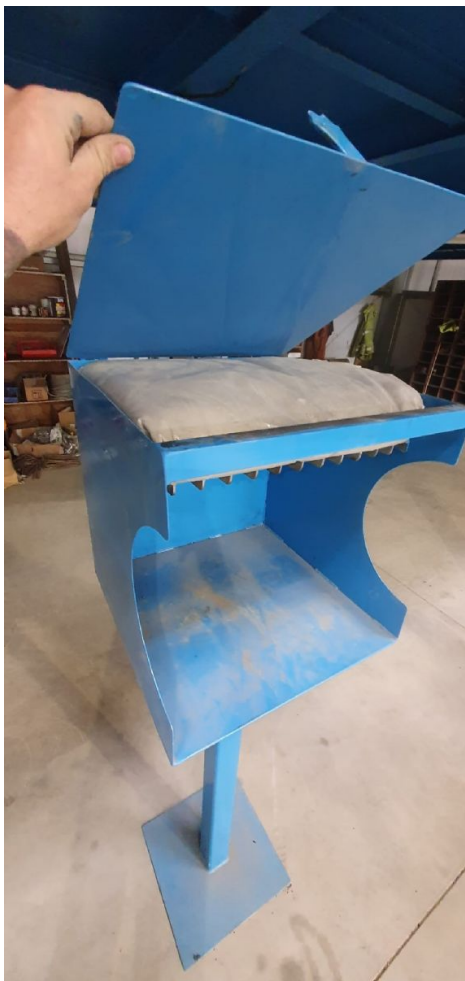
Please see the **additional pdf**, the images below and the video to find out about the solution developed to reduce the risk of fire when re-charging the batteries.

The engineer carried out a risk analysis of charging these types of batteries and started to look at the Hierarchy of Control. The charging of batteries could not be eliminated or substituted as returning to mains cabled power tools in a quarrying environment was reintroducing risk to the operations that had been eliminated with the introduction of battery powered tools.
