## BEST PRACTICE

LOCATION: Quarry  
ACTIVITY: Manual handling and storage  
SUB ACTIVITY: N/A  
BEST PRACTICE No: BP309  
COUNTRY OF ORIGIN: United Kingdom

**New hopper to remove semi-dry concrete sticking**

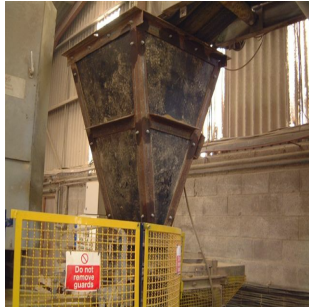
**rubber hopper close-up**

The machine operator led to the development of a hopper lined with thick conveyor rubber. This has produced a hopper that rarely suffers from build-up of semi-dry concrete. This solution has also removed the need for heavy manual intervention as, on the infrequent occasions that the material does build up, a simple tap on the side removes it.
