## BEST PRACTICE

LOCATION: Concrete products plant      ARTICLE YEAR: 2006  
ACTIVITY: Manual handling and storage      COMPANY: CEMEX  
SUB ACTIVITY: N/A      COMPANY LOCATION: Wormit concrete plant, Fife  
BEST PRACTICE No: BP325      COMPANY TEL: 01382 541641  
COUNTRY OF ORIGIN: United Kingdom

**Paddle lock bars for the mixer**

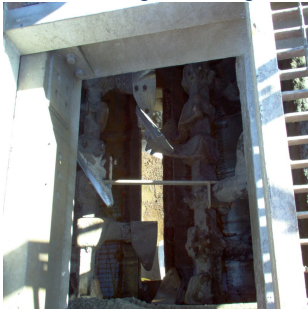
**Millar Mixer**

There was a risk of injury during the manual cleaning of the Millar Mixer. Whilst it was possible to stop the mixer from working, there was still the hazard of the paddles rotating manually during cleaning.

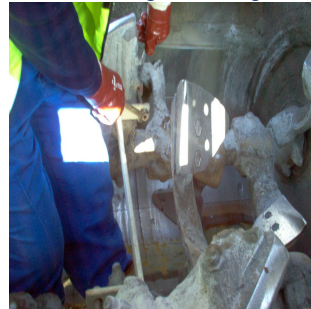
**Paddle lock**

The team at this site came up with a paddle lock to solve the problem. The bar was designed to fit over the paddle arms and be locked into place using bolts and tightened with the use of spanners. This meant that, in order for the paddles to become free again, a tool had to be used - they could not be set in motion by accident.

- ?Bar manufacture less than £200
- ?Risk of accidental entrapment eliminated
- ?Lightweight and easily fitted by one man
- ?Easily modified to fit alternative mixer designs.
