BEST PRACTICE

LOCATION: Concrete products plant ARTICLE YEAR 2006
ACTIVITY: Maintenance & Housekeeping COMPANY: CEMEX
SUB ACTIVITY: N/A COMPANY LOCATION: Wormit concrete plant, Fife
BEST PRACTICE No: BP326 COMPANY TEL: 01382 541641
COUNTRY OF ORIGIN: United Kingdom

Paddle lock bars for the mixer

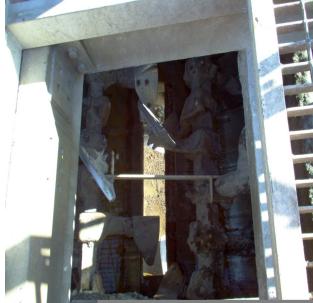
Millar Mixer

There was a risk of injury during the manual cleaning of the Millar Mixer. Whilst it was possible to stop the mixer from working, there was still the hazard of the paddles rotating manually during cleaning.

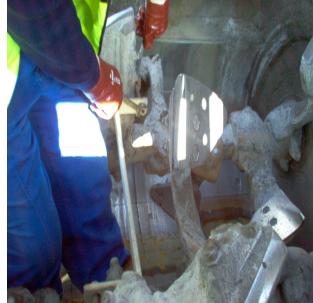
Paddle lock

The team at this site came up with a paddle lock to solve the problem. The bar was designed to fit over the paddle arms and be locked into place using bolts and tightened with the use of spanners. This meant that, in order for the paddles to become free again, a tool had to be used - they could not be set in motion by accident.

- ?Bar manufacture less than £200
- ?Risk of accidental entrapment eliminated
- ?Lightweight and easily fitted by one man
- ?Easily modified to fit alternative mixer designs.
