BEST PRACTICE

| BEST PRACTICE No: | BP359 | COMPANY TEL: | 01274 606479 |

Inclinometer to prevent tipper overturns

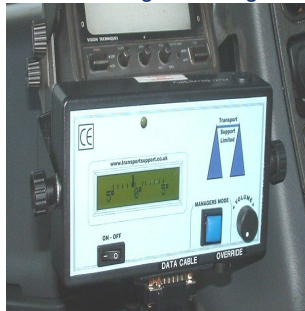
Inclinometer

After several incidents of articulated lorries tipping over when unloading bulk materials at Hanson's UK sites, measures were introduced to address the problem. An inclinometer was fitted to a Hanson articulated tipper. The electronic sensor is attached to the trailer and detects lean, preventing the driver tipping if an unsafe angle is reached.

This original device was not sufficiently sophisticated, however, and was redeveloped to improve reliability and accuracy. Since the modification, drivers have expressed their views that the inclinometer has reduced the risk of overturning and has led to tipping areas which were previously regarded as 'border-line' being re-categorised as unsafe.
