LOCATION:	Quarry	ARTICLE YEAR:	2012
ACTIVITY:	Maintenance & Housekeeping	COMPANY:	Breedon Aggregates
SUB ACTIVITY:	N/A	COMPANY LOCATION:	Cloud Hill Quarry
BEST PRACTICE No:	BP809	COMPANY TEL:	01332 694010
COUNTRY OF ORIGIN:	United Kingdom

**Safe access and egress to binder screen**

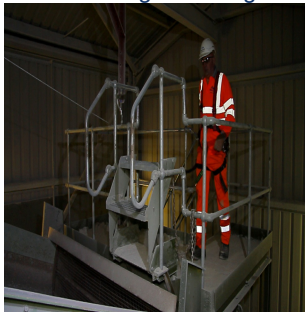
The fitters and site management came up with the idea of creating a stairway and retractable steps to gain access and, in addition, installed a moveable/lockable gate mechanism to prevent falls from the end of the screen into the discharge chute.

Quarry fitters at Breedon Aggregate's Cloud Hill Quarry raised the issue of very poor access to the quarry's main primary binder screen. They were required to access and maintain the top deck finger bars at least once per week with no real means of access. Ladders were used to gain access but as they were carrying tools, they were unable to maintain three points of contact.
