BEST PRACTICE

LOCATION: Asphalt/Coating plant
ACTIVITY: Maintenance & Housekeeping
SUB ACTIVITY: N/A
BEST PRACTICE No: BP849
COUNTRY OF ORIGIN: United Kingdom

Roller Path Maintenance

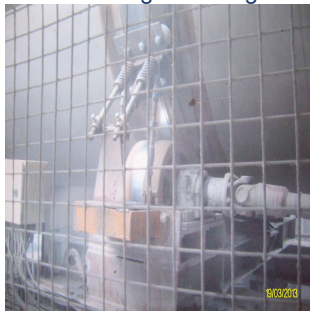
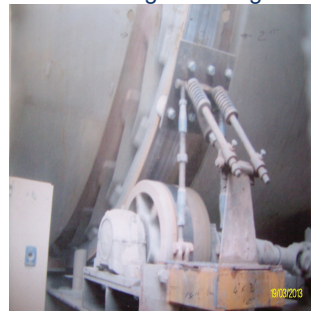
Operatives at Hillhouse Quarry in Troon have designed some equipment to assist with the polishing and re-instating of the dryer drum roller path ring. The apparatus enables any blemishes to be removed from the path without exposing the fitters or operatives to any risk whilst the task is being performed. It consists of a table and rods which hold a plate with fine grinding, countersunk blocks. The blocks have been strategically placed to cover the entire width of the path. The blocks are lightly tensioned using the turnbuckle method. The drum operates normally whilst the grinding is taking place with minimal supervision required. The system works with the isolock guarding in place and is clearly visible at all times.

- The ability to produce normally whilst completing an essential maintenance task
- Ensuring the roller paths are kept in true running condition extended the ring life
- Reduced dryer drum roller path wear
- Extended trunion drive roller life
- No health and safety risk during this task.
