BEST PRACTICE

LOCATION: Quarry
ACTIVITY: Maintenance & Housekeeping
SUB ACTIVITY: N/A
BEST PRACTICE No: BP864
COUNTRY OF ORIGIN: United Kingdom

ARTICLE YEAR: 2013
COMPANY: Midland Quarry Products
COMPANY LOCATION: Cliffe Hill Quarry
COMPANY TEL: 07968 544064

Safe removal of shovel tooth from stalled primary gyratory crusher

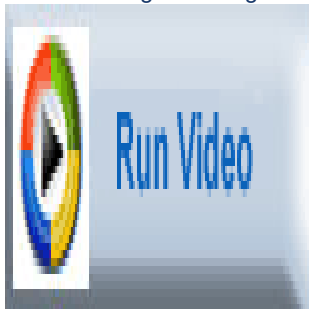
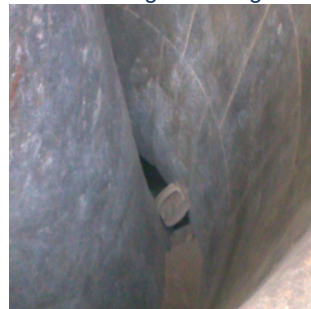
MPQ fabricated a purpose built, crescent shaped, steel plate to manage this risk when removing a bucket tooth trapped in the primary gyratory crusher at Cliffe Hill Quarry. Once all other materials had been removed the crusher, a jib crane lowered the purpose built plate into position over the trapped tooth. The lifting chains were left in place and to add more weight, the crane "block" was lowered onto the plate and a "Pecker" blade was also placed on it. A two man team, both wearing a safety harness, were positioned in the in the tipper box which had been previously cleared of all material. They used a thermal lance inserted between slots in the steel plate to dislodge the tooth.
