BEST PRACTICE

LOCATION:	Cement plant	ARTICLE YEAR	2014
ACTIVITY:	Maintenance & Housekeeping	COMPANY:	CEMEX UK
SUB ACTIVITY:	N/A	COMPANY LOCATION:	Rugby Cement Works
BEST PRACTICE No:	BP909	COMPANY TEL:	07785-547882
COUNTRY OF ORIGIN:	United Kingdom

Installation of airbags to provide additional overhead protection

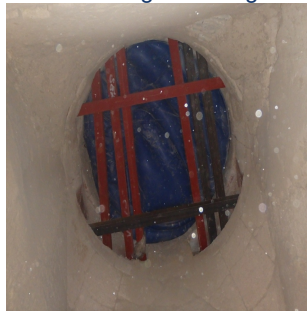
In addition to the standard roof protection nets fitted to the refractory lining in the Hog's Back, it was decided to trial a series of airbags, and three were installed at different levels in the ducting. They sat on steel beams, and were designed to cushion and absorb the impact of anything falling from above. The airbags sealed tight up against the side of the Downcomer ducting.

- Re-usable system.
- Rugged construction.
- Can be manufactured to any size application.
- Tested by the Building Research Establishment and each capable of withstanding at least 400 kg from 9m.
- Relatively quick and easy to install.
- Can be installed at various levels depending upon the application.
