Important Work at Height Lanyards and Fall Arrest Equipment Malfunction Alert!

It has come to our attention that the locking mechanisms on certain models of DMM carabiners may develop a dysfunction.

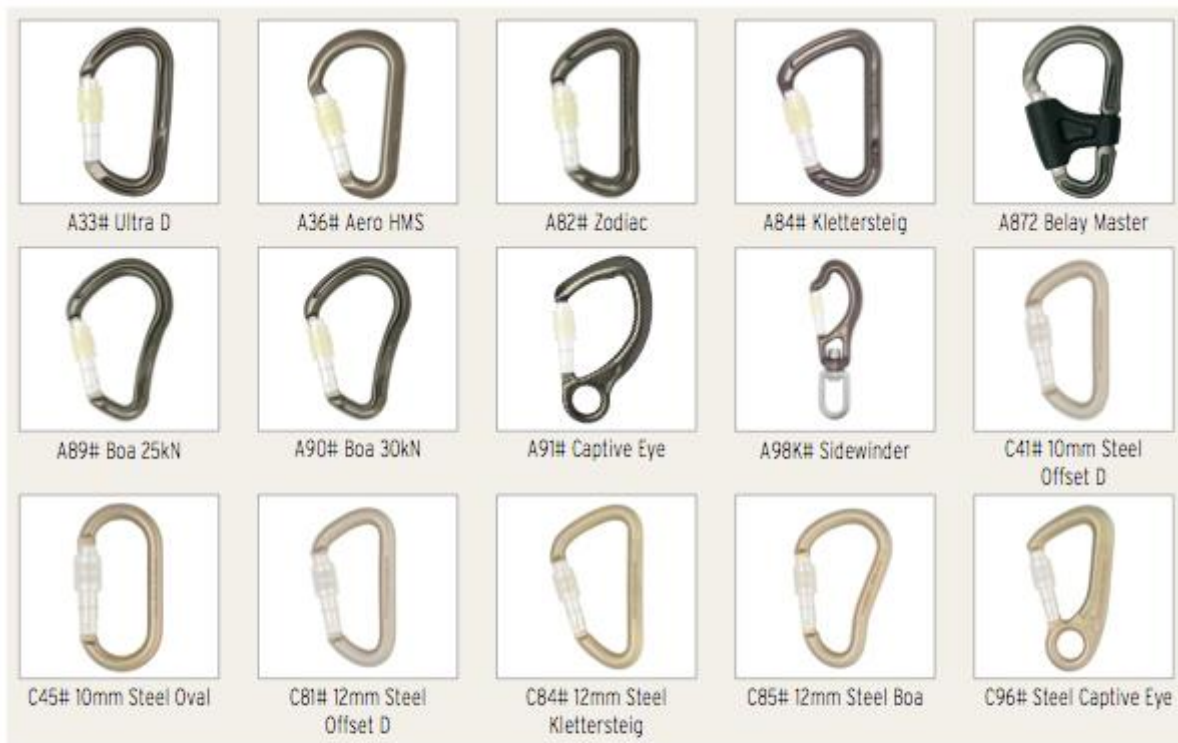
Appendix A

With the following serial numbers (these run sequentially):

2014 Production - **14138xxxxX to 14365xxxxX**

2015 Production - **15001xxxxX to 15254xxxxX**

The serial number can be found on the spine of the carabiner.

Affected Carabiner Models

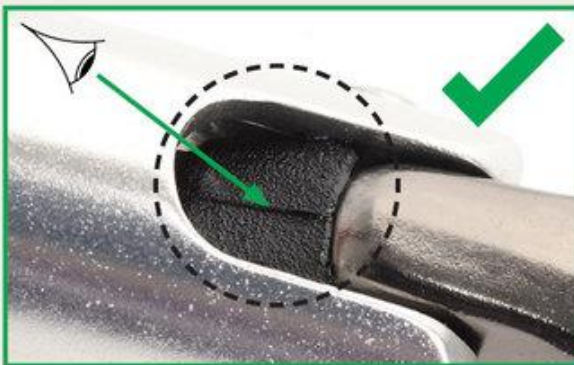
MOULDING LINE = OK

OK, NO RECALL

no dysfunction

Do not return to DMM, continue use.

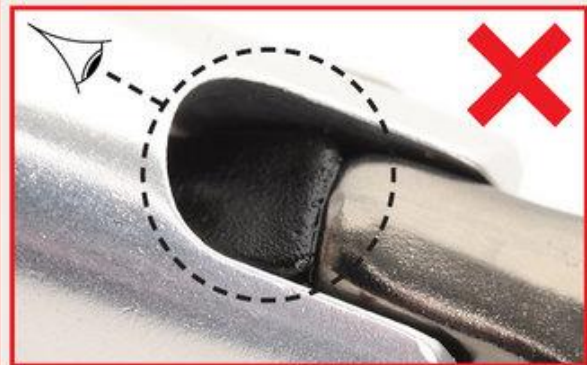
NO MOULDING LINE = RECALL

RECALL

risk of dysfunction - DO NOT USE

Immediately retire from service, quarantine and await further instructions from DMM.

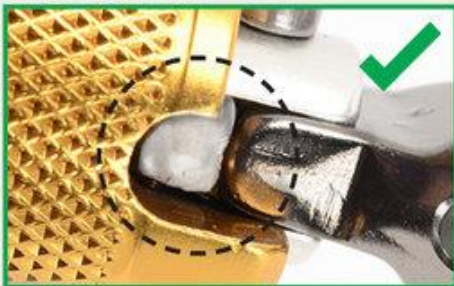
OK, NO RECALL

Certain specialist carabiners utilise a stainless steel spring pusher. This is silver/grey in colour and is unaffected by the recall.
